# Aesthetics versus function: the fall of the Dee bridge, 1847

PETER R. LEWIS and COLIN GAGG

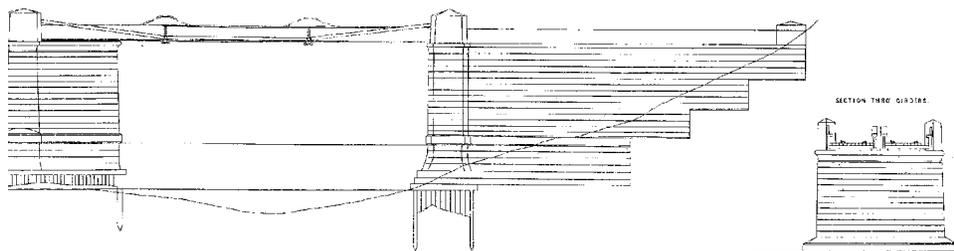
1 Section of composite girder, shown straddling stone piers, with transverse section at right: the span seems to be supported over much of the length of the first casting, but this is a false perspective owing to the angle of the track

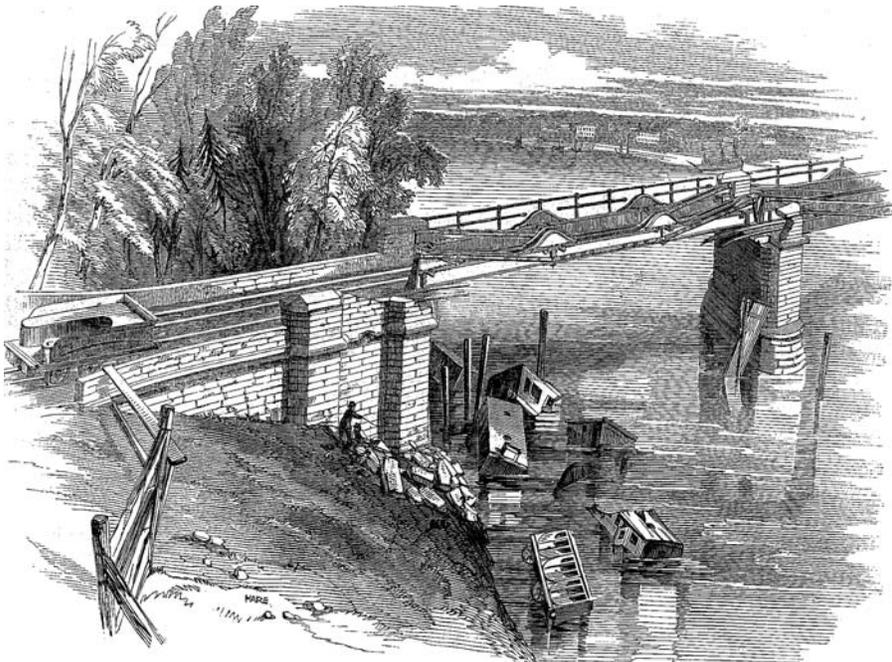
2 View of disaster site in etching from *Illustrated London News* of 12 June 1847: the view is from the south bank of the Dee looking north west along the river, with the tender at extreme left and the damage to the abutment visible at centre

some spurious additions, such as the fanciful backdrop showing berthed schooners and other ships, an impossible vista from the position taken by the artist.<sup>4</sup> However, the foreground bears close comparison with the known facts as surveyed by the accident investigators. The driver (Clayton) was the only uninjured survivor, and with great presence of mind he drove the locomotive another half mile to Saltney station, where he raised the alarm. He then crossed over onto the opposite track, and courageously recrossed the bridge so that he could warn other trains of the danger. Fortunately there were many locals who had seen the accident, and the survivors were soon rescued from the river.

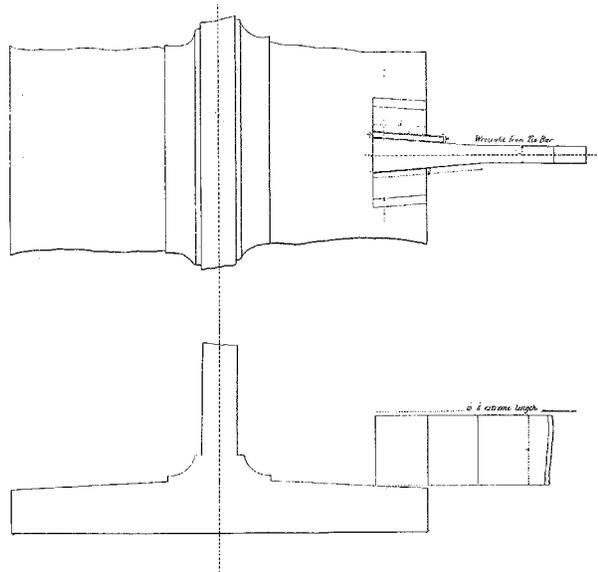
4 Plan and section of cast iron flange of single casting: plan (above) shows the dovetail joint with lateral wrought iron tie bar which held the parallel girders together; below is a section of the flange with an oak beam at right

The inner corners of the girder were not smoothly rounded out, but given a curious shape more like that widely adopted by carpenters working with wooden beams. The section is known as a cavetto moulding, with two sharp corners (fillets) next to the web and flange parts and a concave surface between (Fig. 4, lower). The feature ran along the entire length of the girder on both the inner and outer sides. The fillets are very serious stress raisers, and the load imposed by the track and train will have been concentrated at the corners. Another zone of weakness is present in the lower flange at the points where the horizontal tie bars were attached (Fig. 4, upper).

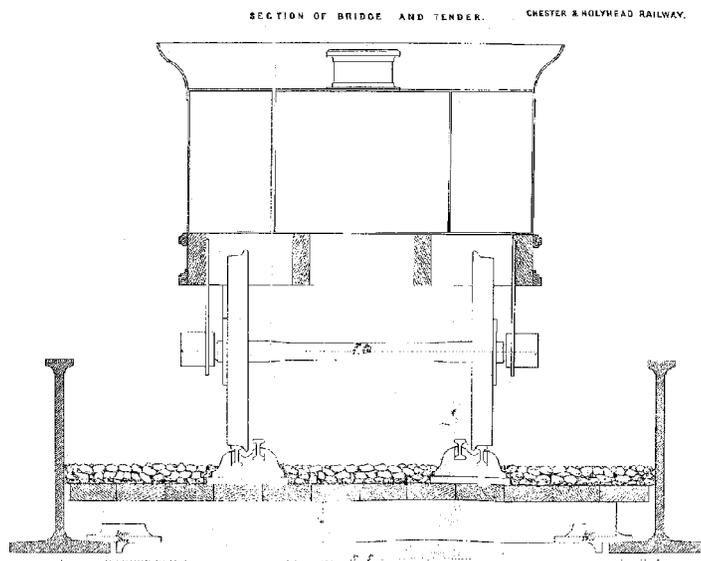
5 Full section showing how track was supported on the Dee bridge, with oak joists on which the sleepers were laid and the double track with guard rail: the oak joists were laid on the inner flanges of the cast iron girders; also shown is the ballast laid on Stephenson's orders on the day of the accident

half an inch, the lower flange moving outwards owing to the asymmetric loading on the girder (Fig. 5). He repeated the measurements with the train moving at around twenty miles per hour, the deflection decreasing to about one and five eighths inches. More significantly, he felt the bridge oscillating beneath him as the train moved across.

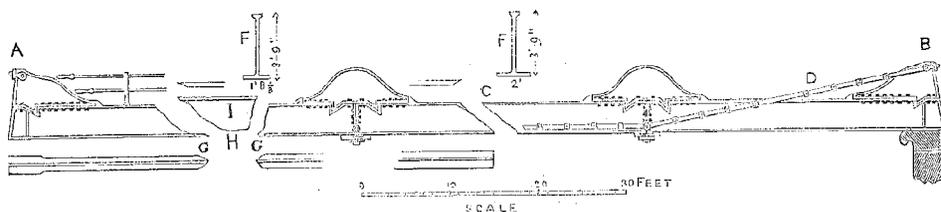
6 Section of broken girder as shown in the *Illustrated London News* a few days after the accident: break at left is shown in great detail, perhaps because the parts had not separated; the centre break which caused the accident was more complex than shown, and several parts were lost in the river

shows much more detail of the break in the abutment casting. Part of the lower flange appears to be missing, presumably lost in the river, and the profile is not inconsistent with fracture starting here and then growing into the upright web so as to eject the large fragment I. The abutment fracture was incomplete, because Simmons shows the casting intact in his plan of the accident scene.

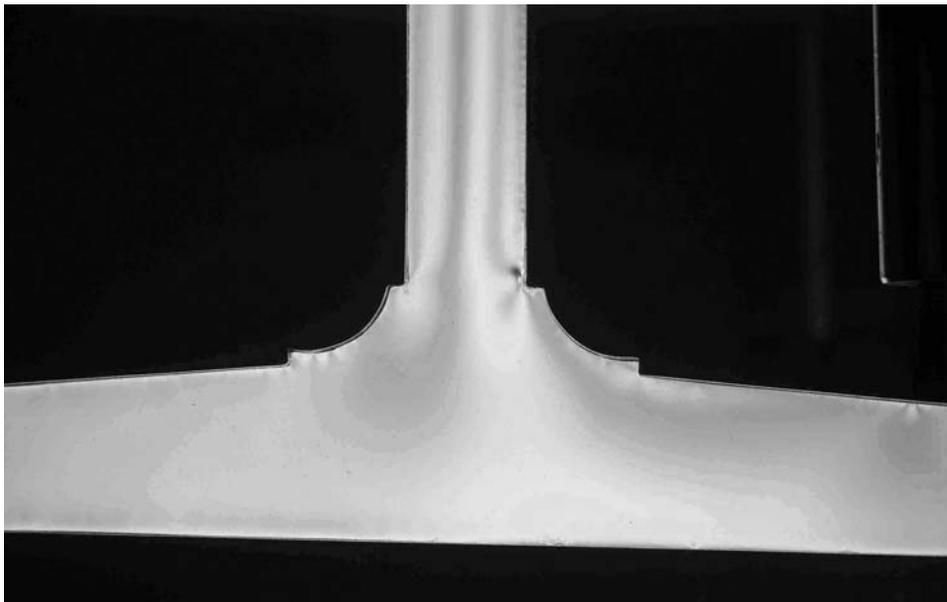
But which of the two corners represents the most serious stress raiser? A direct experiment was attempted using polaroscopy. A scale section of the casting was machined from four millimetre thick polycarbonate sheet, a polymer with a high stress optical coefficient. The right hand flange was bent downwards in a polariscope, producing the birefringence pattern shown in Fig. 7. The upper corner of the cavetto section is where most of the applied stress is concentrated, and so where fracture will have started in the cast iron beam. By adding such a decorative feature to a structural beam, the designer unwittingly weakened it catastrophically. Aesthetic features may have been suitable on plinths for statues, but were quite inappropriate for structural components.

7 Section of model of girder with one flange strained by load at right, seen in polarised light, crossed so as to show internal stresses: upper corner of cavetto section is weakest part judging by high number of fringes; load concentration is seen by a similar dimple at right

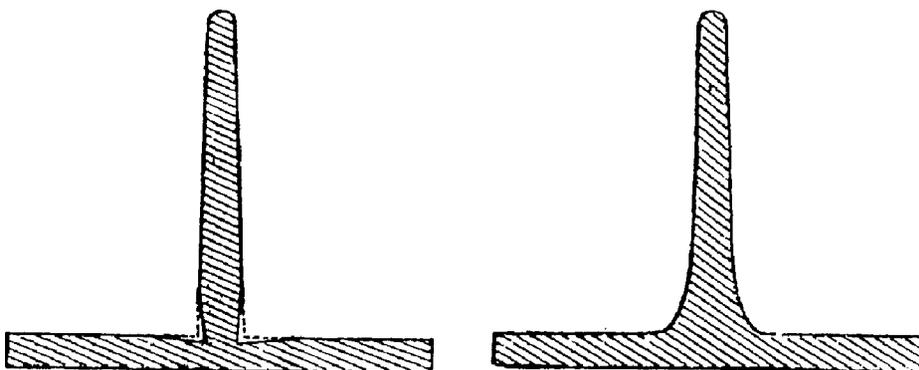
8 Illustrations from William Humber's book on iron bridges and girders published in 1857. At left, defective cast iron girder with sharp corners produced by excessive shrinking of metal: Humber was unaware of the stress concentration effect of sharp corners, but did know that such girders were much weaker than expected; at right, the best form of a cast iron girder according to Humber: the corners are rounded, so reducing shrinkage, although (as we now know) amelioration of the stress raiser is much more important

Stephenson. The author goes on to talk about defects in castings, and makes very specific reference to inner corners. Indeed, his very first diagram is of the lower corners of a cast iron girder (Fig. 8, left). The diagram shows the excessive shrinkage which occurs here, and the sharp corner produced: 'Not only is the beam weakened by this, but the grain will be found to be much closer in the angles than in the other parts of the ribs, and an unequal strain in the material itself must be the consequence.' He then recommends a corner shape as shown in Fig. 8 (right), where the corners have been rounded to counteract

the shrinkage. He says that this design modification has been proved by numerous experiments. Humber was obviously unaware that the most important effect of rounding sharp corners is to reduce the stress concentration, and so strengthen the final product.
