Forensic engineering: a reappraisal of the Tay Bridge disaster

PETER R. LEWIS and KEN REYNOLDS

The Tay Bridge disaster

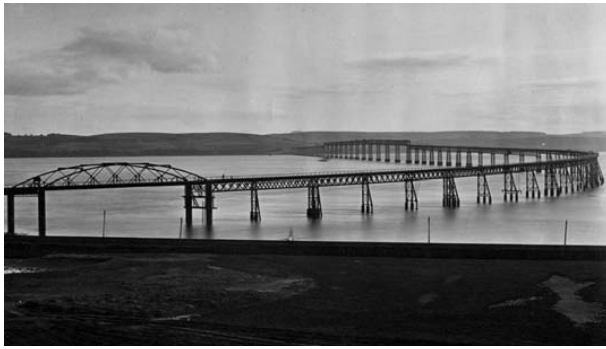
1 The Tay Bridge just after completion, showing the centre or 'high girders' section needed to allow passage of high masted sailing ships upstream along the river to Perth (clearance was about twenty-seven metres at high tide). Some finishing work was still being performed on the bridge, judging by the staging and ladders seen at various points

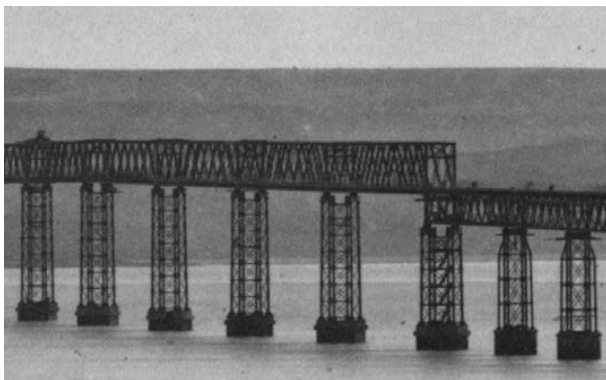
2 Closeup of the join between the high girders at left and the low girders at right on the Dundee side of the bridge. The centre of each high tower shows the diagonal tie bars and horizontal struts which united the two sub-towers. Unlike the low tower at extreme right, the tops of the high towers are not reinforced by complete girders

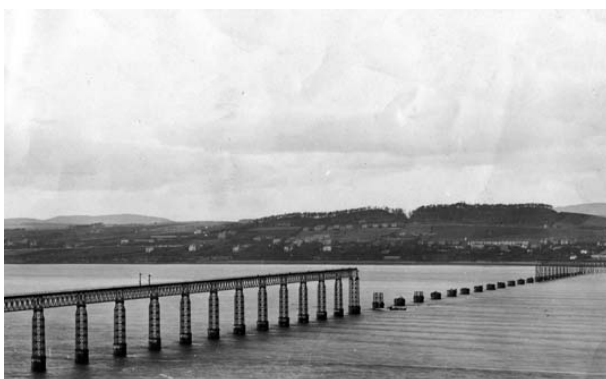
3 Long shot of the collapsed high girders section of the bridge, with twelve pier platforms almost completely swept off their high towers

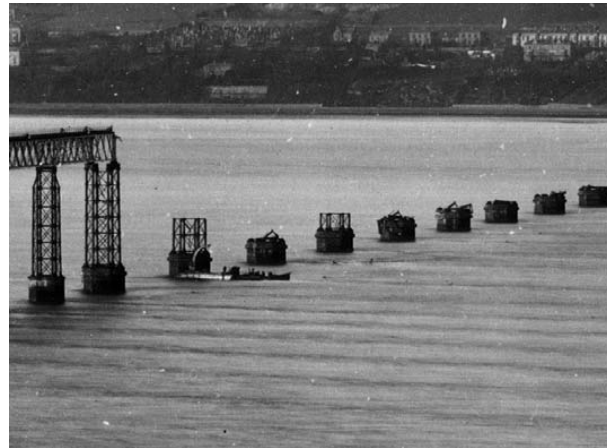
4 Closeup of the join between the low and high sections of the bridge showing partly intact tiers on two piers. The boat in the foreground is searching for survivors in the girders, which are just visible in front of the third fallen pier, poking above the waterline. Numerous tie bar breaks can be seen in the centre of the last standing tower

standing towers of the low sections, although some of the west facing bars were also fractured at their lug attachments (Fig. 4).

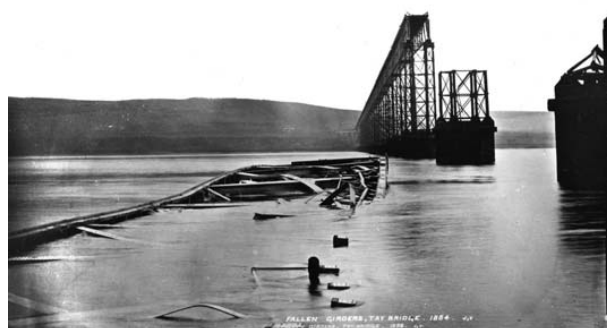
day, they found no survivors or bodies. The high girders were resting on the estuary bed, in a remarkably intact state and partly exposed at low tide (Fig. 5). Divers later found the train resting between the fourth and fifth piers, relatively little damaged

5 Side of the high girders seen at low tide. The girders were found almost intact close to the pier bases, and laid out in a wave form alongside the high section of the bridge

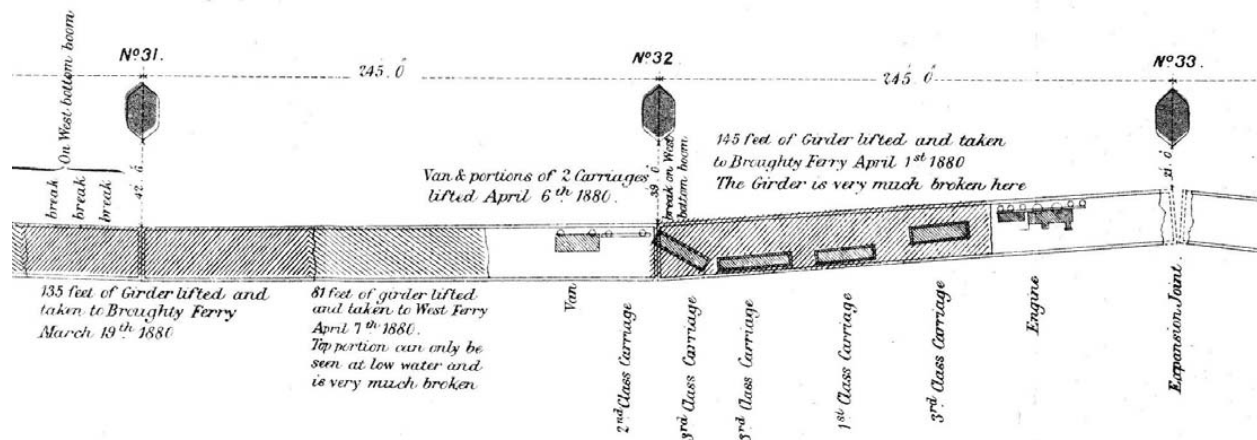
except for the guard's van and the final passenger carriage (Fig. 6). The locomotive (a new 4-4-0 engine) had only superficial damage, and would later be restored to a long working life.

6 Plan of the section of the high girders between the fourth (no. 32) and fifth (no. 33) piers, showing the nearly intact train with the 4-4-0 locomotive at the front

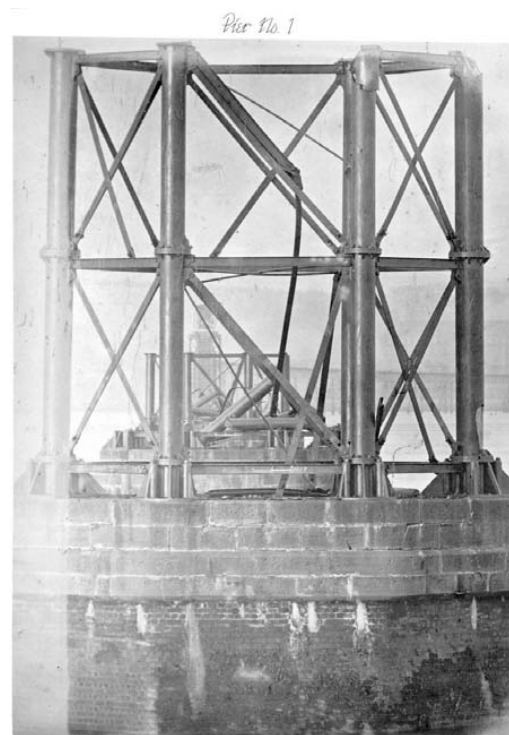
outside edges of the lugs holding bracing bars for each column (Fig. 9). There are nine such lug ends shown in Fig. 8, and while some may have come from adjacent broken tie bars (Fig. 10), the rest must have come from the missing higher tiers. Moreover, the two partly standing piers showed that the centre bracing bars facing east were most likely broken (Fig. 7). A similar pattern appears on the two fully

7 Two partly intact tiers on the first pier, photographed from the south looking north. East facing tie bars have all broken on the centre cells, while the west facing tie bars are intact. Breakage has occurred consistently at the lower lugs

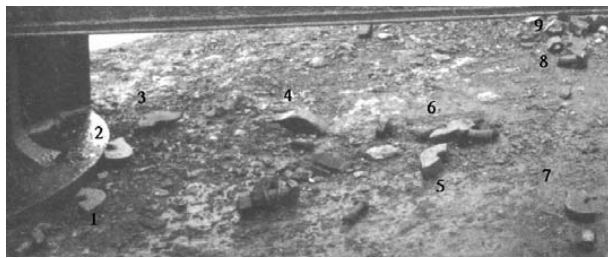
What we found most revealing was the nature of the debris on these two partly standing piers. Because most of the superstructure had been swept away, the stone platforms were relatively clear of debris, apart from fractured wrought iron bolts and broken pieces of cast iron of almost identical shape (Fig. 8). It turned out that these lumps of cast iron were the

8 Debris field with nine lug ends plus nuts and bolts on the platform of the third pier (looking east). Base of fifteen inch column at left showing structure of cottered joint

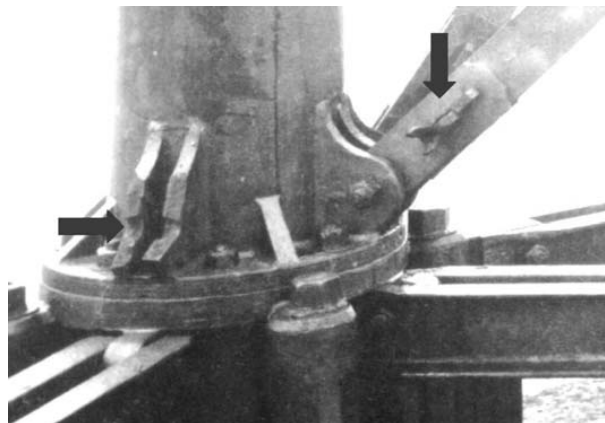
10 Broken lower lug on third pier (looking west), showing conical taper on bearing surface for one and an eighth inch bolt (lefthand arrow). The narrowest part of the hole is an inch and a quarter in diameter, so producing a large stress concentration at the contact zone. Joint at right shows gap between cotter and slot, allowing loosening with time (righthand arrow)

the taper section lugs, ill fitting bolts (Fig. 10), and the lack of a continuous connection at the head of the column where the high girder was supported by the pier. In effect, each tower consisted of two separate subtowers connected solely by the bracing bars and struts lying on an east–west axis (Fig. 2). That each subtower fell separately was suggested by the remains at the fifth pier, where the east tower lay under the high girder and the west on top. This observation was made by John Cochrane, an engineer called by Sir Thomas Bouch.

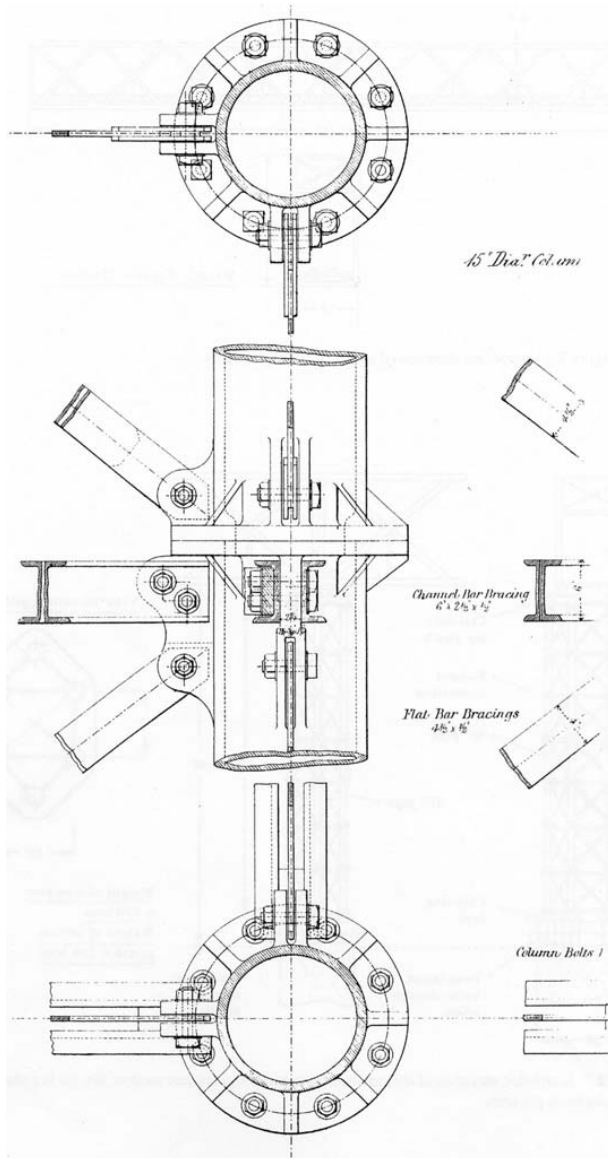
9 Line drawing of various joints on fifteen inch diameter column, including upper and lower lugs, strut, and flange, all cast as one with the column (Institution of Civil Engineers)

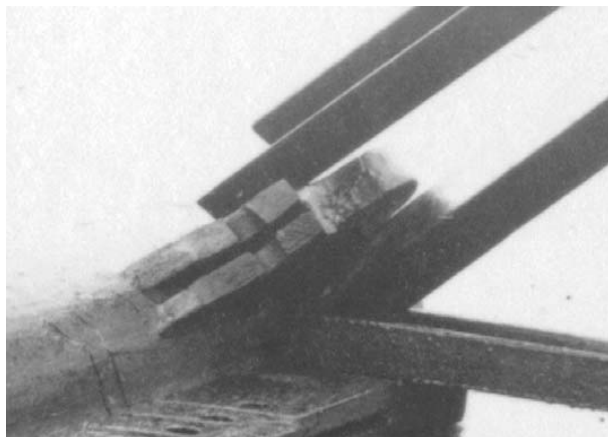
11 Conical taper on broken upper lug. The column shows part of a lifting wing used during raising of the girders

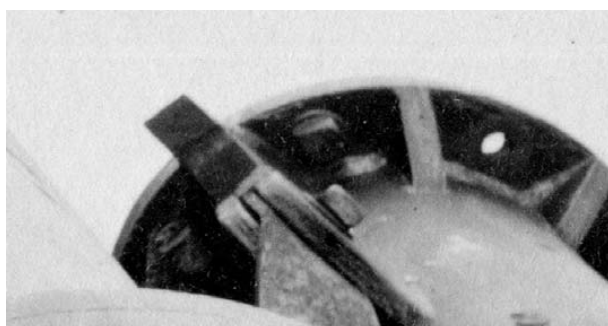
12 Conical taper on broken strut lug with intact upper lug joint in foreground

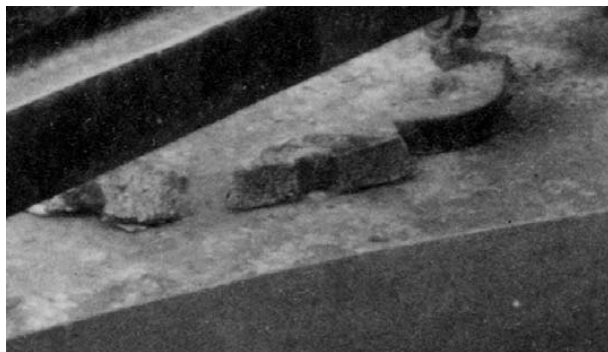
13 Closeup of three broken lugs from twelfth pier. The centre sample shows numerous crack arrest lines with a small blowhole on the lefthand wing of the lug, probably indicating intermittent crack growth (fatigue)

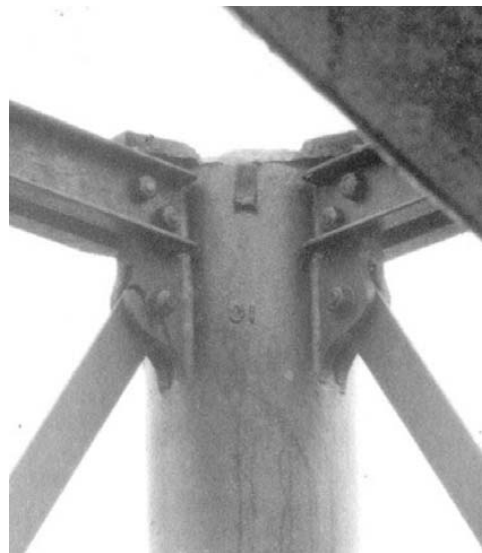
14 Closeup of fractured lug on third pier (looking west). Only one wing of the lefthand lug has broken, suggesting cyclic loading during or before the accident and collapse of the tower. There are no washers on the strut bolts, and these appear to be tightened by different amounts (judging by differing thread heights above the nuts)

representing intermittent growth. There is supporting evidence for a fatigue mechanism from the several partly cracked lugs seen in the photographs. One example from about six found so far is shown in Fig. 14: one wing of the lug is broken, whilst the other is intact, suggesting at least one cycle of tensile load. Even today, hairline fatigue cracks in flake (or grey) cast iron products are very difficult to spot, and it is hardly surprising that neither the painters nor Mr Noble detected them.

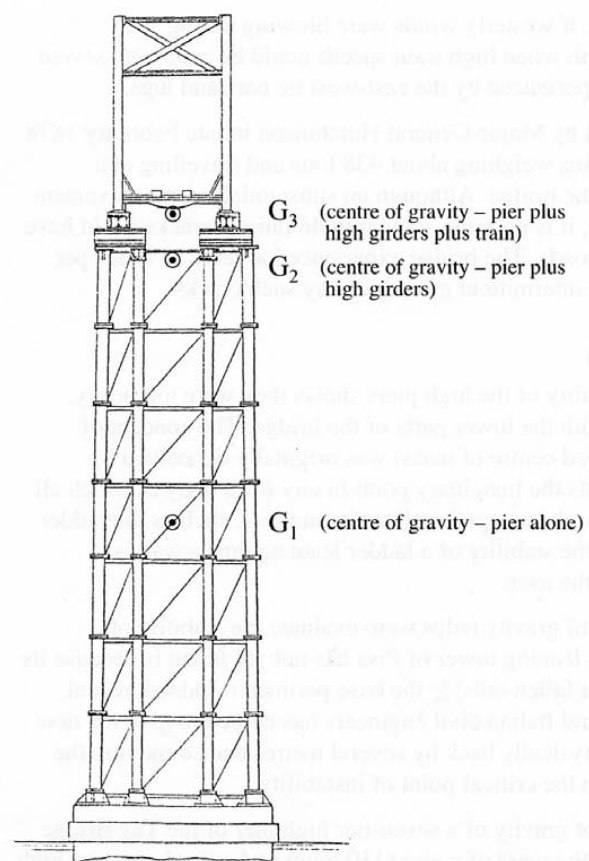
15 The towers in the high girders section of the bridge were top heavy, the centre of gravity lying near the level of the track when the express train from Edinburgh crossed on the night of 28 December 1879

tower of just over a hundred tons. The towers were even lighter in the original design, being completely hollow, however someone decided to fill them with Portland cement, increasing the total mass. The weight of the high girders was also increased when it was decided to cover the wooden trackway with ballast. The rise in centre of gravity is shown in Fig. 15. Thus each tower in the high girders section was very top heavy, much more so than those in the low section owing to the greater distance between piers and the heavier girders needed to span this greater distance (Fig. 16).

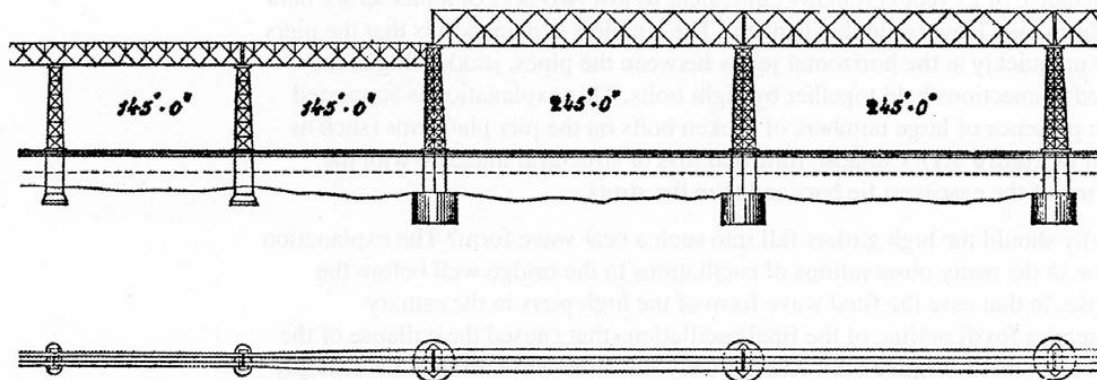
TAY BRIDGE, ARRANGEMENT OF PIERS & GIRDERS.

- 16 The centres of gravity of the towers in the lower part of the bridge were much lower because the piers were closer together and supported smaller girders of lower weight, which helps to explain why they survived the collapse
