Forensic engineering: a reappraisal of the Tay Bridge disaster

PETER R. LEWIS and KEN REYNOLDS

The Tay Bridge disaster

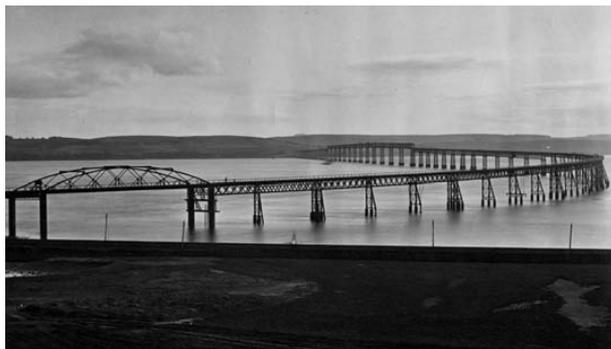
1 The Tay Bridge just after completion, showing the centre or 'high girders' section needed to allow passage of high masted sailing ships upstream along the river to Perth (clearance was about twenty-seven metres at high tide). Some finishing work was still being performed on the bridge, judging by the staging and ladders seen at various points

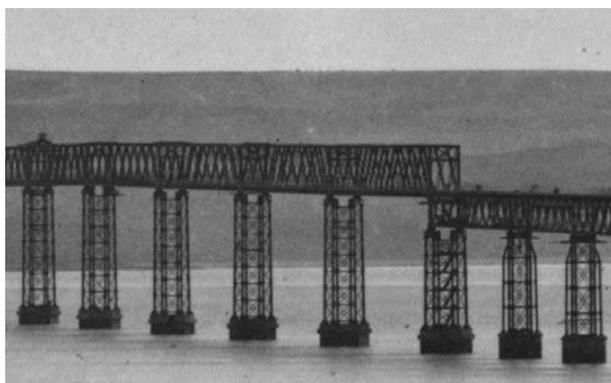
2 Closeup of the join between the high girders at left and the low girders at right on the Dundee side of the bridge. The centre of each high tower shows the diagonal tie bars and horizontal struts which united the two sub-towers. Unlike the low tower at extreme right, the tops of the high towers are not reinforced by complete girders

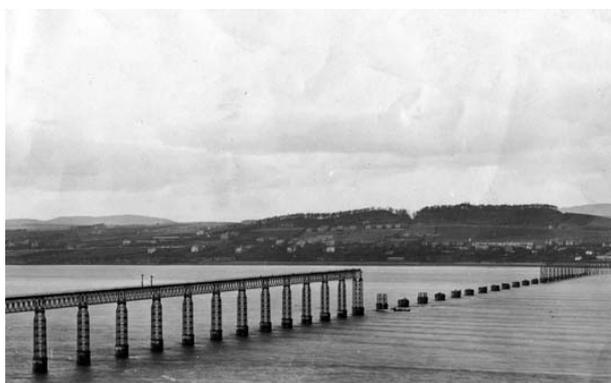
3 Long shot of the collapsed high girders section of the bridge, with twelve pier platforms almost completely swept off their high towers

When the express entered the high girders, the greater weight of the train (well over a hundred tons) would have produced critical movement to aid toppling of the towers over which the train passed. Each tower behaved as though composed of two separate towers linked by struts and tie bars alone. The train nearly reached the fifth tower before collapse overtook it, probably starting at the southern end and working progressively forwards until the entire high girders section had been swept away. That all the towers in the section had deteriorated is amply demonstrated by their state after the accident (Figs. 3 and 4).

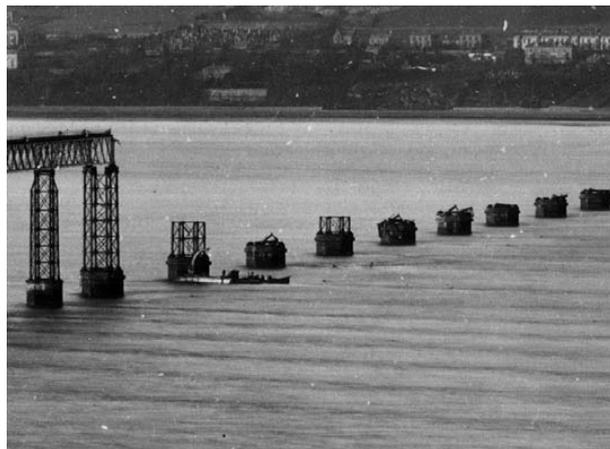
4 Closeup of the join between the low and high sections of the bridge showing partly intact tiers on two piers. The boat in the foreground is searching for survivors in the girders, which are just visible in front of the third fallen pier, poking above the waterline. Numerous tie bar breaks can be seen in the centre of the last standing tower

standing towers of the low sections, although some of the west facing bars were also fractured at their lug attachments (Fig. 4).

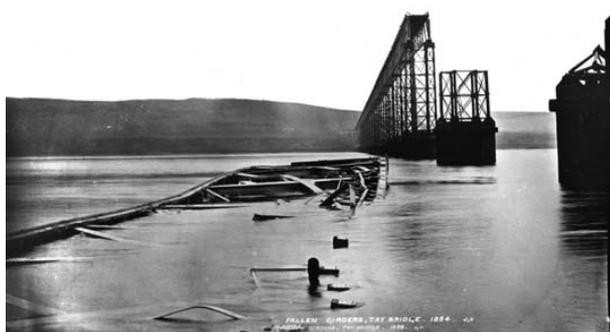
day, they found no survivors or bodies. The high girders were resting on the estuary bed, in a remarkably intact state and partly exposed at low tide (Fig. 5). Divers later found the train resting between the fourth and fifth piers, relatively little damaged

5 Side of the high girders seen at low tide. The girders were found almost intact close to the pier bases, and laid out in a wave form alongside the high section of the bridge

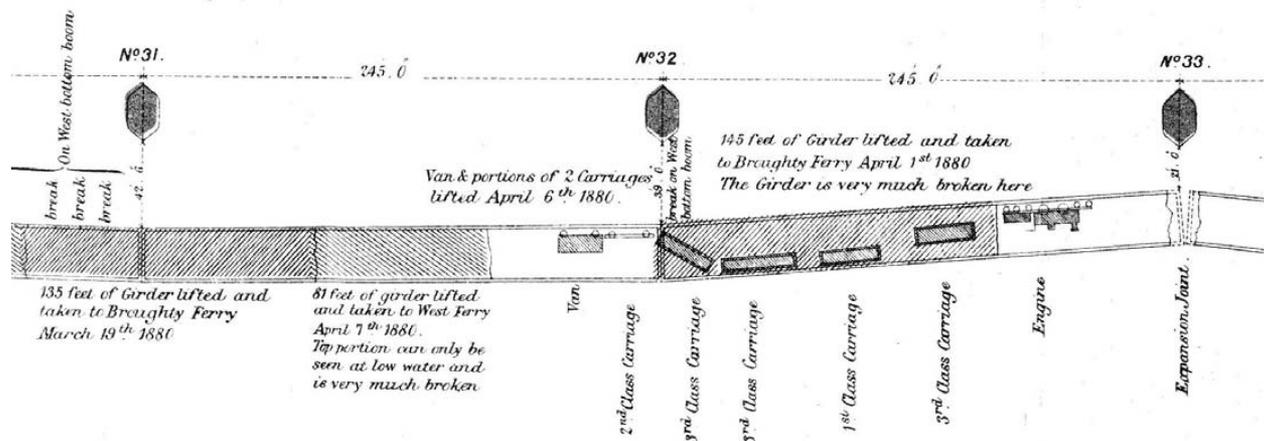
6 Plan of the section of the high girders between the fourth (no. 32) and fifth (no. 33) piers, showing the nearly intact train with the 4-4-0 locomotive at the front

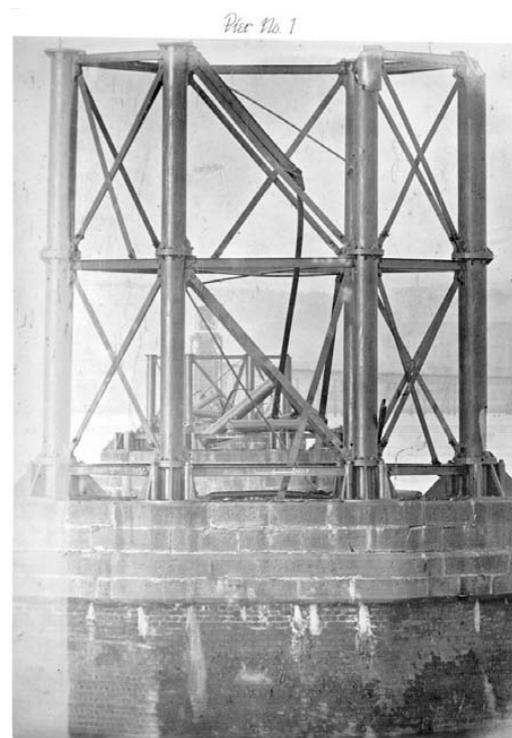
outside edges of the lugs holding bracing bars for each column (Fig. 9). There are nine such lug ends shown in Fig. 8, and while some may have come from adjacent broken tie bars (Fig. 10), the rest must have come from the missing higher tiers. Moreover, the two partly standing piers showed that the centre bracing bars facing east were most likely broken (Fig. 7). A similar pattern appears on the two fully

7 Two partly intact tiers on the first pier, photographed from the south looking north. East facing tie bars have all broken on the centre cells, while the west facing tie bars are intact. Breakage has occurred consistently at the lower lugs

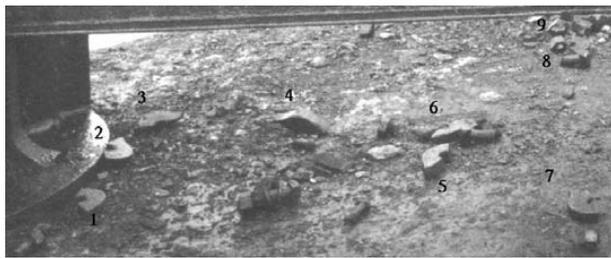
What we found most revealing was the nature of the debris on these two partly standing piers. Because most of the superstructure had been swept away, the stone platforms were relatively clear of debris, apart from fractured wrought iron bolts and broken pieces of cast iron of almost identical shape (Fig. 8). It turned out that these lumps of cast iron were the

8 Debris field with nine lug ends plus nuts and bolts on the platform of the third pier (looking east). Base of fifteen inch column at left showing structure of cottered joint

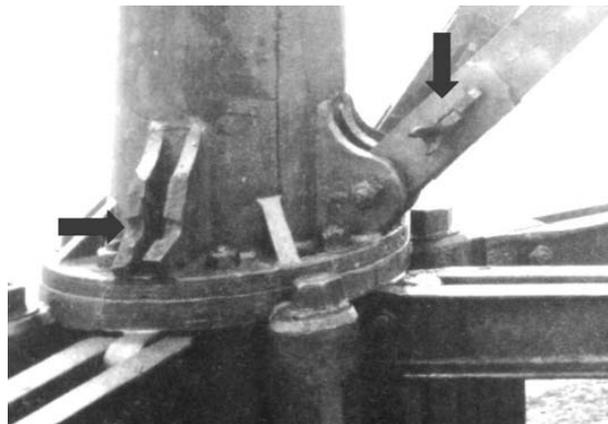
10 Broken lower lug on third pier (looking west), showing conical taper on bearing surface for one and an eighth inch bolt (lefthand arrow). The narrowest part of the hole is an inch and a quarter in diameter, so producing a large stress concentration at the contact zone. Joint at right shows gap between cotter and slot, allowing loosening with time (righthand arrow)

the taper section lugs, ill fitting bolts (Fig. 10), and the lack of a continuous connection at the head of the column where the high girder was supported by the pier. In effect, each tower consisted of two separate subtowers connected solely by the bracing bars and struts lying on an east–west axis (Fig. 2). That each subtower fell separately was suggested by the remains at the fifth pier, where the east tower lay under the high girder and the west on top. This observation was made by John Cochrane, an engineer called by Sir Thomas Bouch.

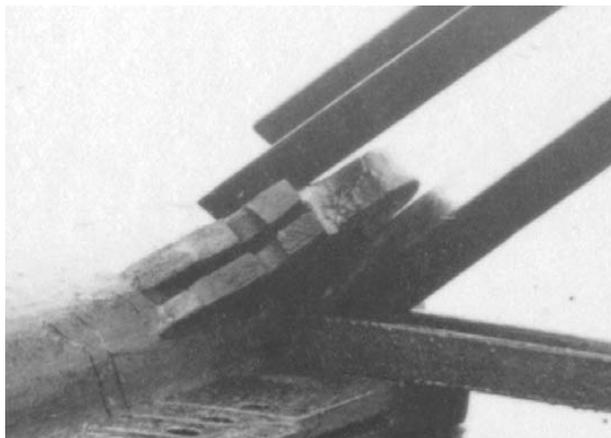
11 Conical taper on broken upper lug. The column shows part of a lifting wing used during raising of the girders

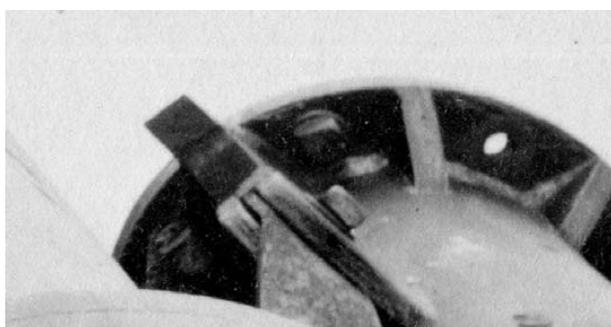
12 Conical taper on broken strut lug with intact upper lug joint in foreground

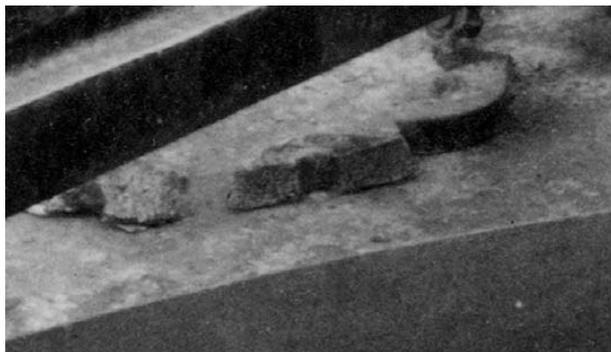
13 Closeup of three broken lugs from twelfth pier. The centre sample shows numerous crack arrest lines with a small blowhole on the lefthand wing of the lug, probably indicating intermittent crack growth (fatigue)

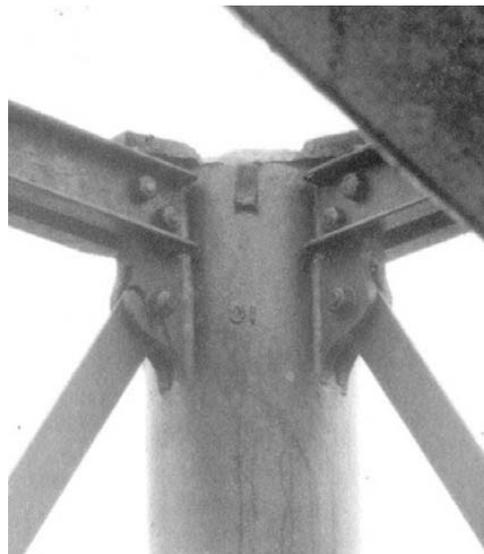
14 Closeup of fractured lug on third pier (looking west). Only one wing of the lefthand lug has broken, suggesting cyclic loading during or before the accident and collapse of the tower. There are no washers on the strut bolts, and these appear to be tightened by different amounts (judging by differing thread heights above the nuts)

representing intermittent growth. There is supporting evidence for a fatigue mechanism from the several partly cracked lugs seen in the photographs. One example from about six found so far is shown in Fig. 14: one wing of the lug is broken, whilst the other is intact, suggesting at least one cycle of tensile load. Even today, hairline fatigue cracks in flake (or grey) cast iron products are very difficult to spot, and it is hardly surprising that neither the painters nor Mr Noble detected them.

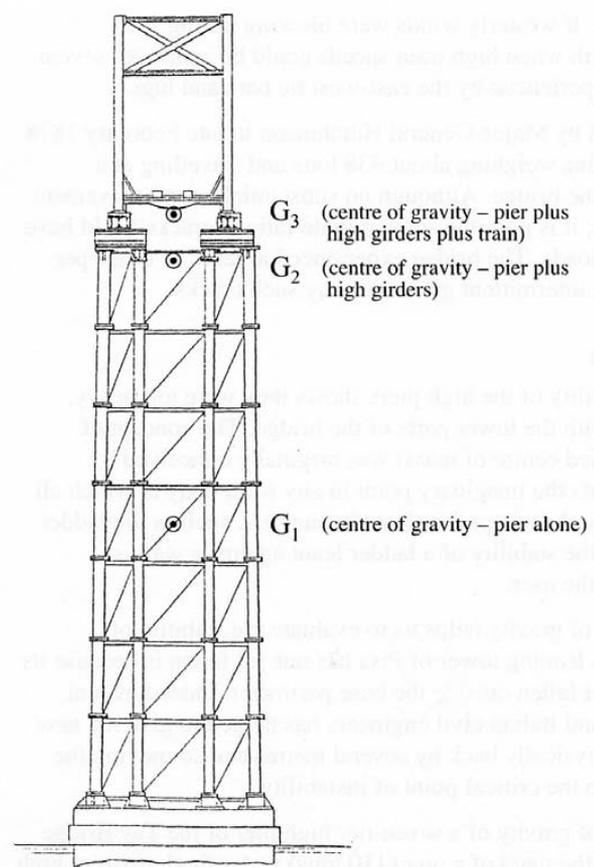
15 The towers in the high girders section of the bridge were top heavy, the centre of gravity lying near the level of the track when the express train from Edinburgh crossed on the night of 28 December 1879

tower of just over a hundred tons. The towers were even lighter in the original design, being completely hollow, however someone decided to fill them with Portland cement, increasing the total mass. The weight of the high girders was also increased when it was decided to cover the wooden trackway with ballast. The rise in centre of gravity is shown in Fig. 15. Thus each tower in the high girders section was very top heavy, much more so than those in the low section owing to the greater distance between piers and the heavier girders needed to span this greater distance (Fig. 16).

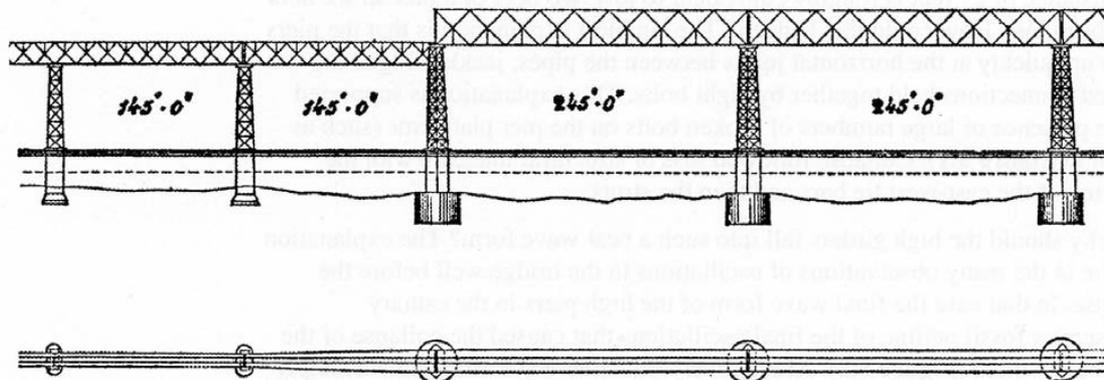
TAY BRIDGE, ARRANGEMENT OF PIERS & GIRDERS.

- 16 The centres of gravity of the towers in the lower part of the bridge were much lower because the piers were closer together and supported smaller girders of lower weight, which helps to explain why they survived the collapse
