# Aesthetics versus function: the fall of the Dee bridge, 1847

PETER R. LEWIS and COLIN GAGG

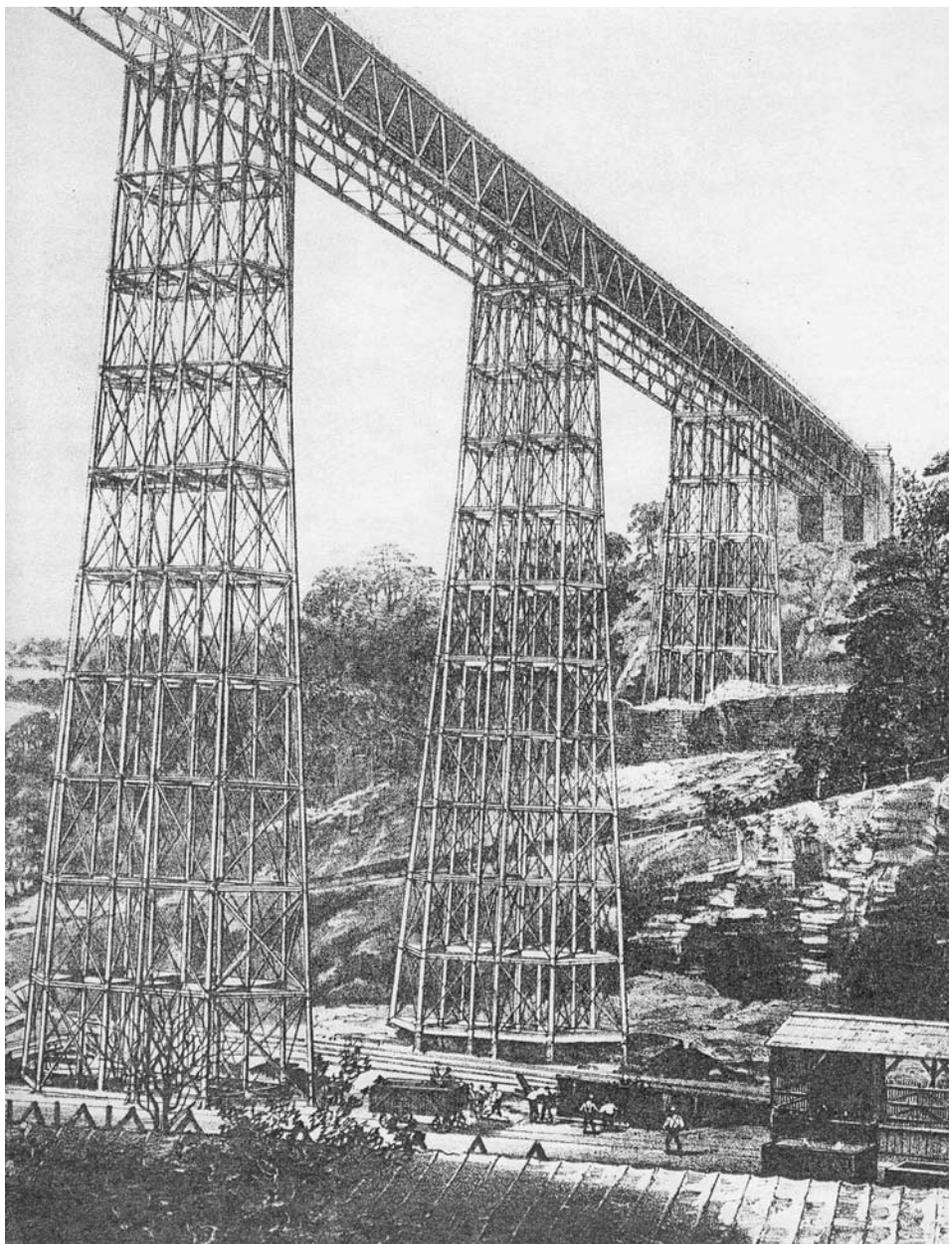
9 Frontispiece to Humber's book showing view of Crumlin viaduct, which was begun in 1853 and opened to rail traffic in 1857: the structure was eighteen hundred feet long, stood two hundred feet above the river, and supported a double rail track
