Forensic engineering: a reappraisal of the Tay Bridge disaster

PETER R. LEWIS and KEN REYNOLDS

The Tay Bridge disaster

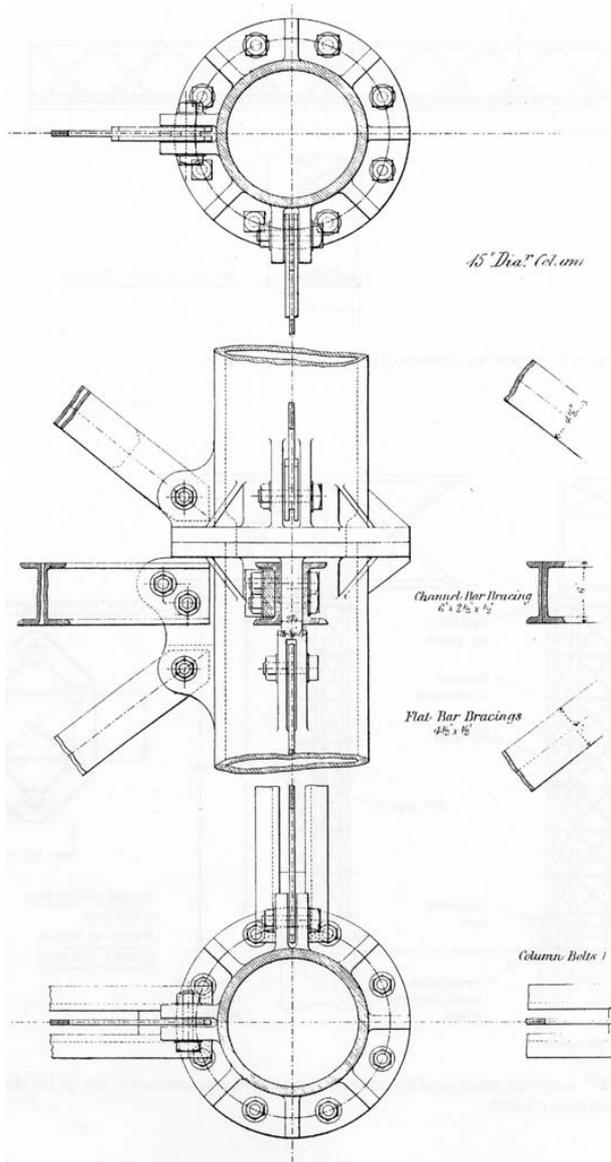
outside edges of the lugs holding bracing bars for each column (Fig. 9). There are nine such lug ends shown in Fig. 8, and while some may have come from adjacent broken tie bars (Fig. 10), the rest must have come from the missing higher tiers. Moreover, the two partly standing piers showed that the centre bracing bars facing east were most likely broken (Fig. 7). A similar pattern appears on the two fully

9 Line drawing of various joints on fifteen inch diameter column, including upper and lower lugs, strut, and flange, all cast as one with the column (Institution of Civil Engineers)

of the vital east-west tie bars which braced the columns together and were held by the lugs. It clearly demanded cross-examination of foundrymen still resident in the area at the time of the original inquiry. All the cast iron was made at the local Wormit foundry, but their evidence proved contradictory. The suggestion that there were 'cold shut lines' on the lugs, for example, is not borne out by our direct inspection of enlargements of the lugs (such as that shown in Fig. 10). These defects occur where the metal parts at a hole and then recombines at the other side. If the metal is too cool, a shut line forms and is a clear weakness in the lug. Moreover, close inspection of the fractures showed that the bolt holes were not drilled out to give a parallel bearing surface for the bolts. On the contrary, the holes were cast as one with the lug and column, and given a taper. This was a serious design defect because it produced a severe stress concentration, over and above that caused by the hole, when the bolt was stressed during straining of the bracing bars. The effect must have been to raise the stress at the outer edge of the hole by well over three times the nominal applied stress. In addition, it was observed by Henry Law, expert adviser to the inquiry team, that the bolt diameter was one and an eighth inches to fit the narrowest part of the tapered hole of an inch and a quarter. The bolts were thus a very loose fit, inducing another stress raising factor into the equation. Our inspection of the photographs revealed that *all* connection holes in the structure were tapered, apart from the flange holes in the cast iron columns, which were drilled. Figure 11 shows the bolt holes on an upper lug, whilst Fig. 12 shows an example on a strut joint. Cross-examination of the foundrymen showed that the lugs were a problem from the start, with many breaking in the yard from impacts. Attempts had been
